Subj: VP-7 AAR ser 1-64A concerning SP-2E BuNo 131481 accident  
occurring 11 May 1964, pilot KOPP

## AIRCRAFT ACCIDENT REPORT

18. BRIEF DESCRIPTION OF MISHAP <b>COLLISION WITH WATER, CAUSE UNKNOWN</b>		19. ELEVATION AT TIME OF MISHAP <b>S L 0 TETRAIN 0</b>		
20. LIST MODEL & NO. REPORTING CUSTODIAN AND DAMAGE CLASSIFICATION OF ANY OTHER A/C INVOLVED (Complete OPNAV Form 3750-1 for each A/C)

PART VI - DAMAGE TO THE AIRCRAFT

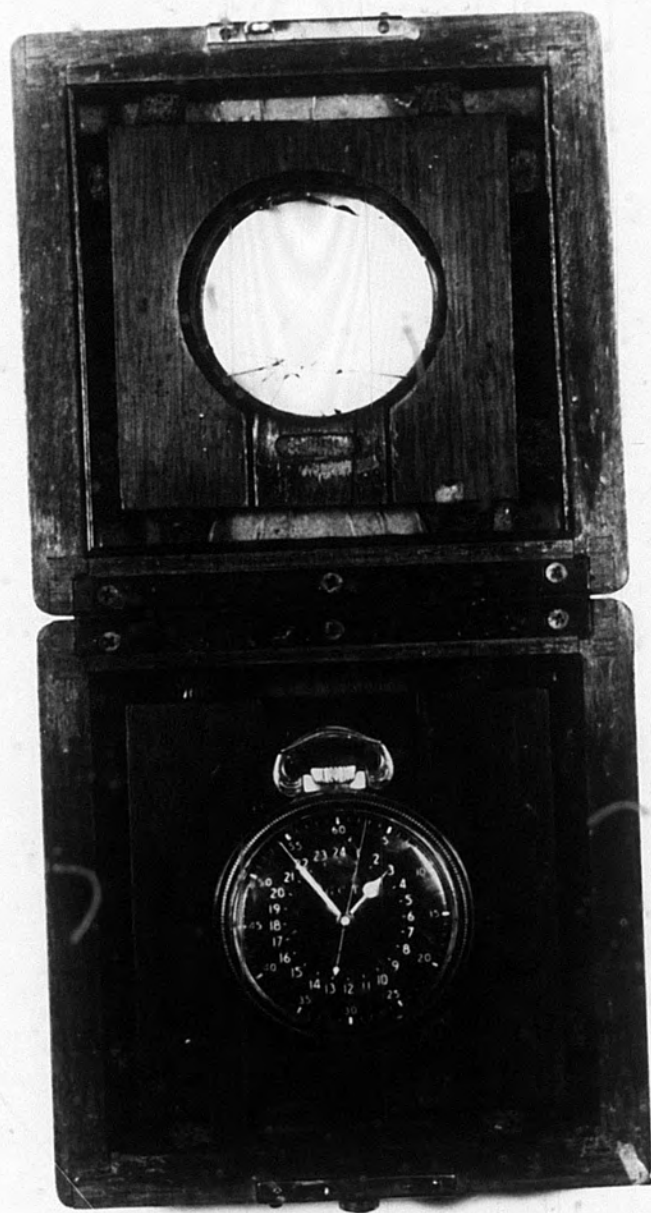
# NAVIGATOR'S CHRONOMETER.

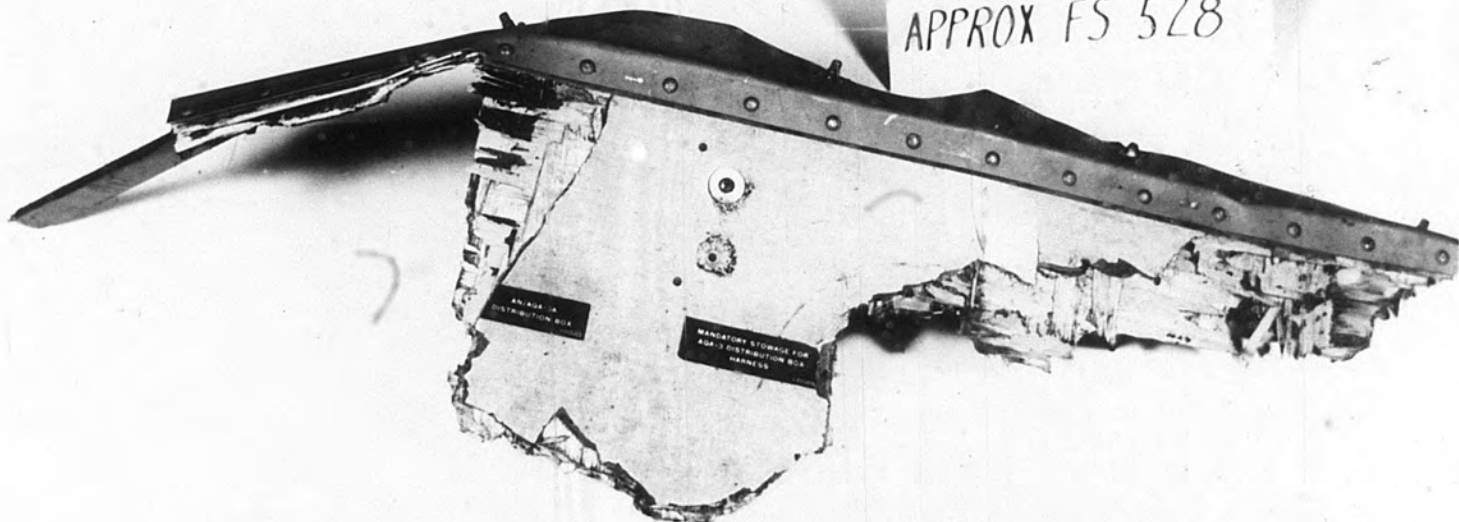
EXHIBIT (8)

WAIST SECTION  
STORAGE LOCKER.  
TOP OUTBOARD EDGE  
FROM FS 484 TO  
APPROX FS 528

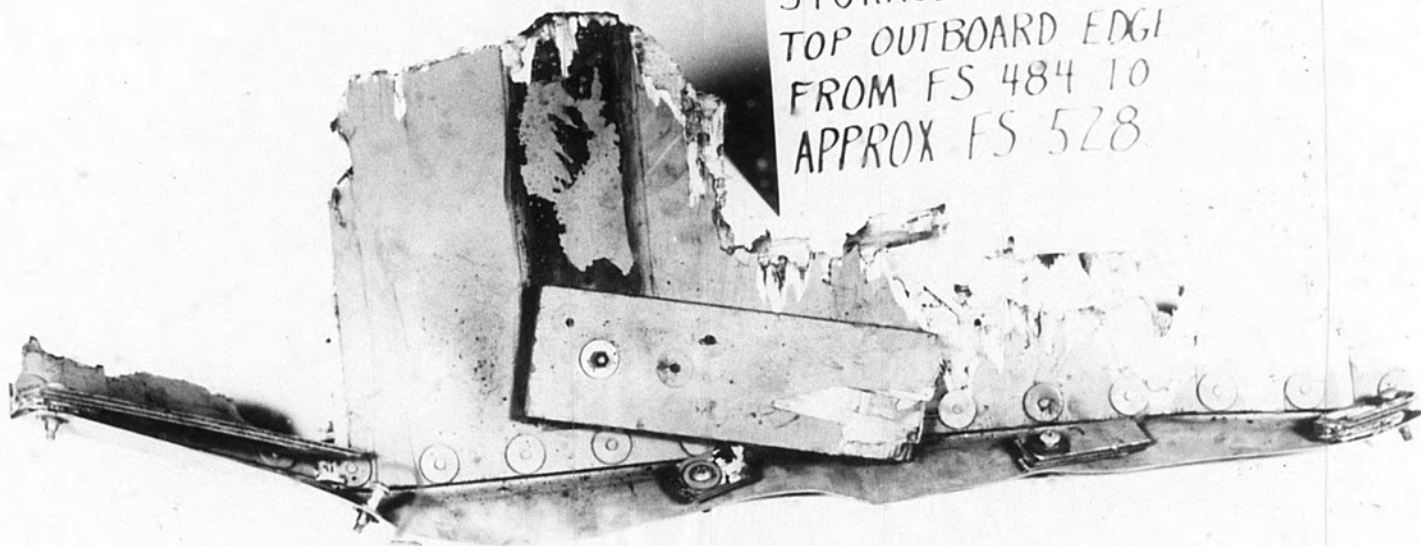
EXHIBIT (C-1)

WAIST SECTION  
STORAGE LOCKER.  
TOP OUTBOARD EDGE  
FROM FS 484 TO  
APPROX FS 528.

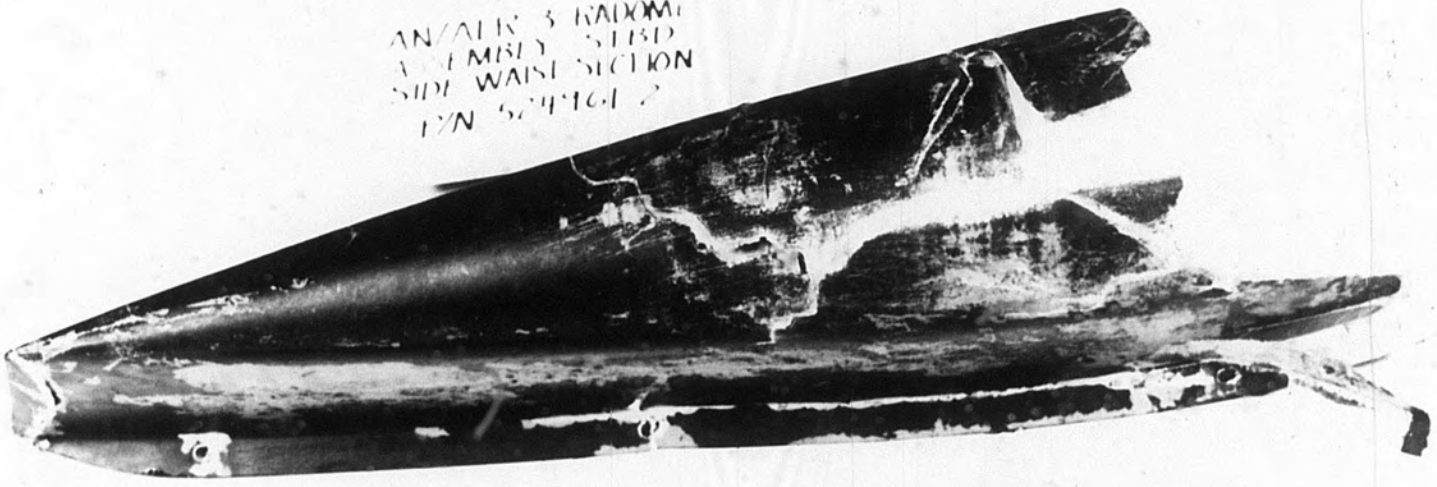
ENCLOSURE (3) EXHIBIT (2)

AN/ALIN 3 RADOM  
ASSEMBLY SUB  
SIDE WAIST SECTION  
PN 544161 2

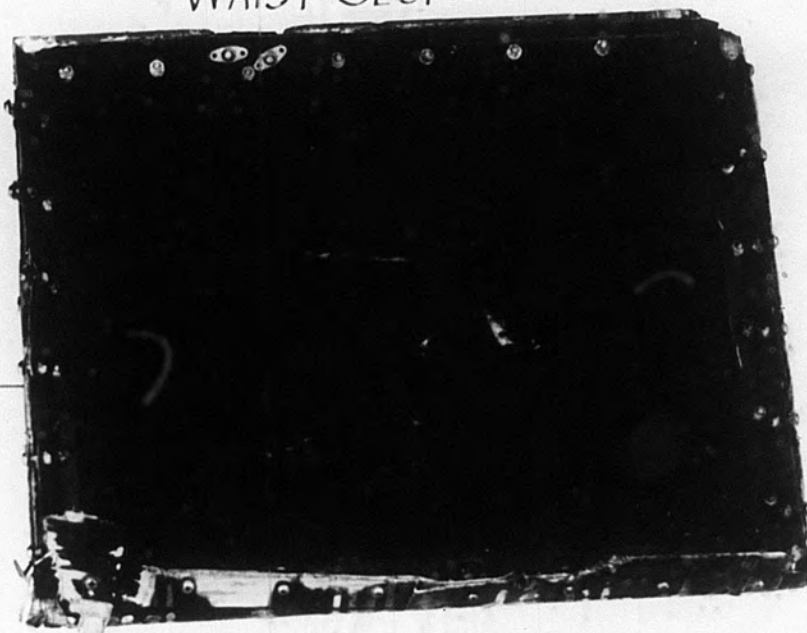
EXHIBIT D

TOP STEP RADIO  
OPERATOR'S  
LOCKER - RADIO  
COMPARTMENT TO  
WAIST SECTION

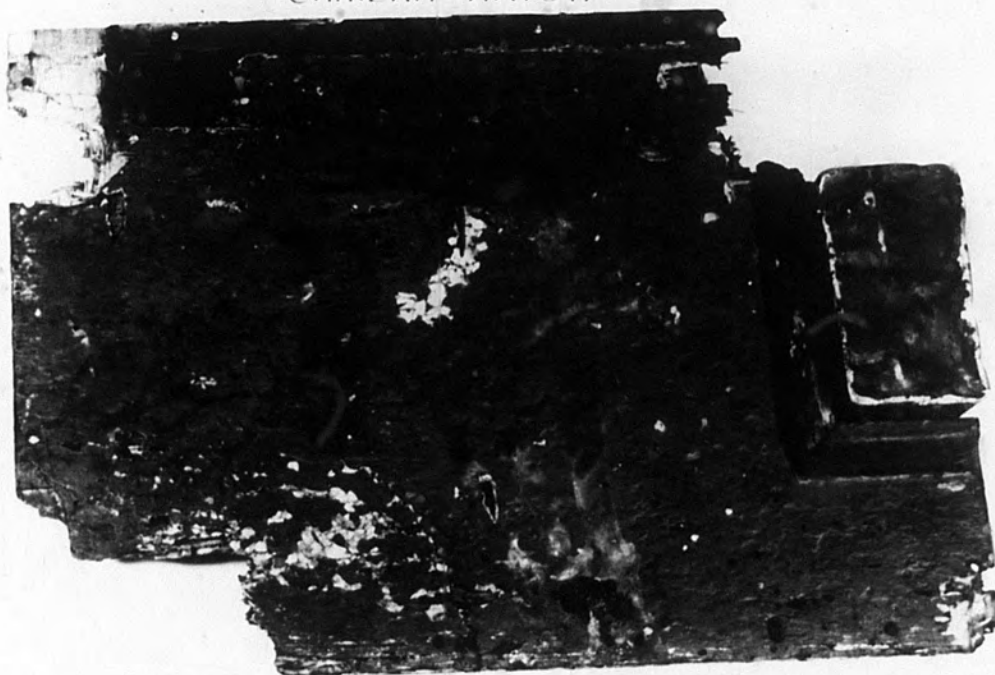
EXHIBIT (5)

WOODEN FLOOR  
BOARD OVER  
WAIST SECTION  
CAMERA HATCH

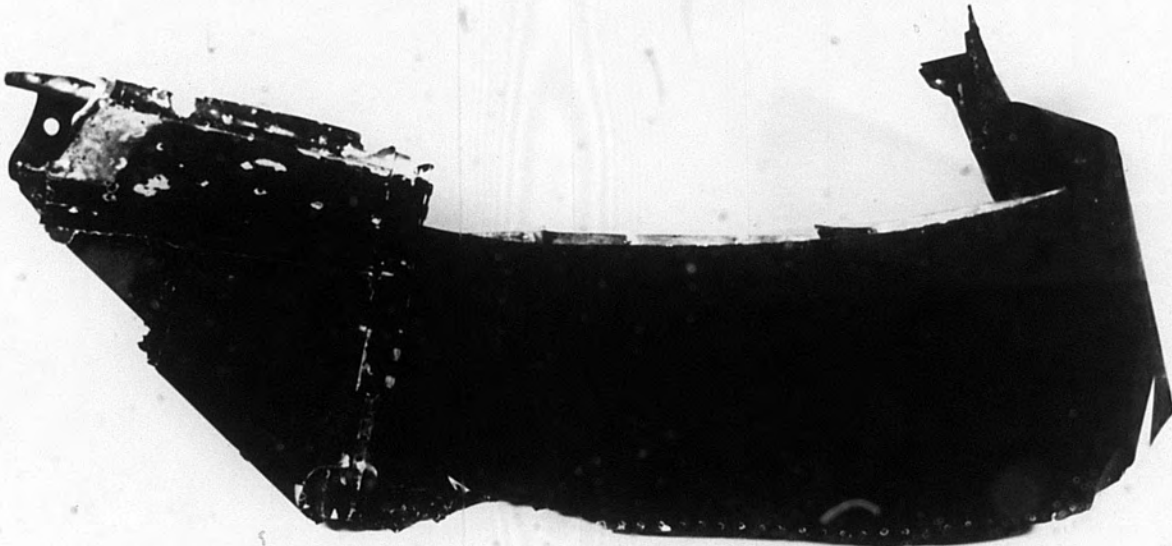
EXHIBIT (F)

AILERON ACCESS  
PANEL, STBD  
WING, BOTTOM  
WS 384 to WS 453

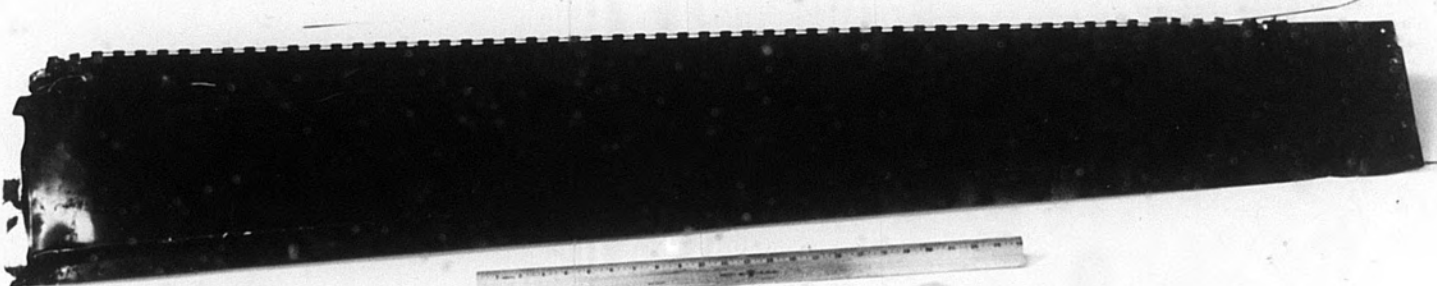
EXHIBIT (6)

ALL FROM ACCESS  
PANEL 180  
WING BOTTOM  
WS 443 to WS 518
